NUMBER: 18-031-03

DATE: Sep. 05, 2003

4.0L Rough Engine Idle After Restart Following A Hot Soak

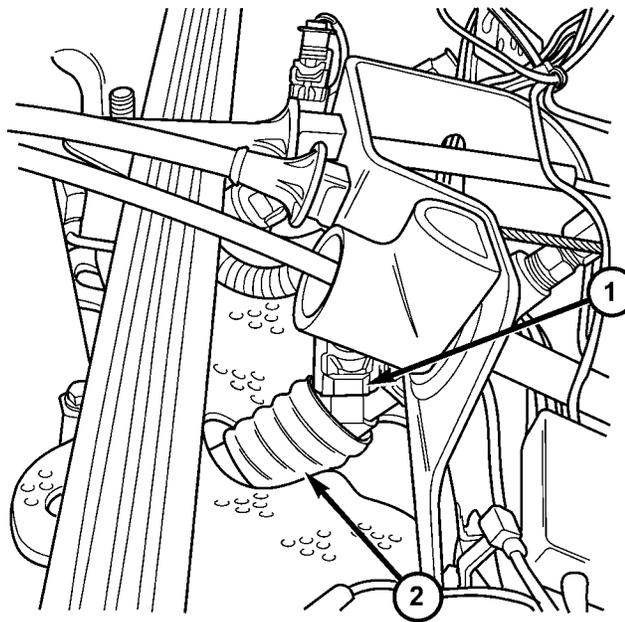
Fig. 1 SLEEVE INSTALLATION

This condition may be caused by heat from the exhaust manifold that following engine shut down migrates to the area around injector #3 and causes fuel vapor to form within the injector. This in turn may cause a momentary misfire of cylinder #3 until the fuel vapor is cleared of injector #3. The insulator sleeve lowers the injector #3 temperature to a point below which the fuel will not normally vaporize.

1. Cut insulator sleeve, p/n 56028371AA, to make two (2) insulator sleeves about 25-30 mm (1 in.) in length.
2. Install one sleeve around injector #3, with the slit on the upward facing side of the injector. Install the other sleeve with the slit on the downward facing side of the injector.
3. Confirm sleeve is flush to intake manifold surface around injector.
4. Check injector #3 wire and ensure that the injector is rotated to a 2 o'clock position (from driver's side of vehicle).

- 1 - # 3 INJECTOR
- 2 - INSTALLED SLEEVE
